# Anchor Head Running into Vertebral Body and Not Advancing

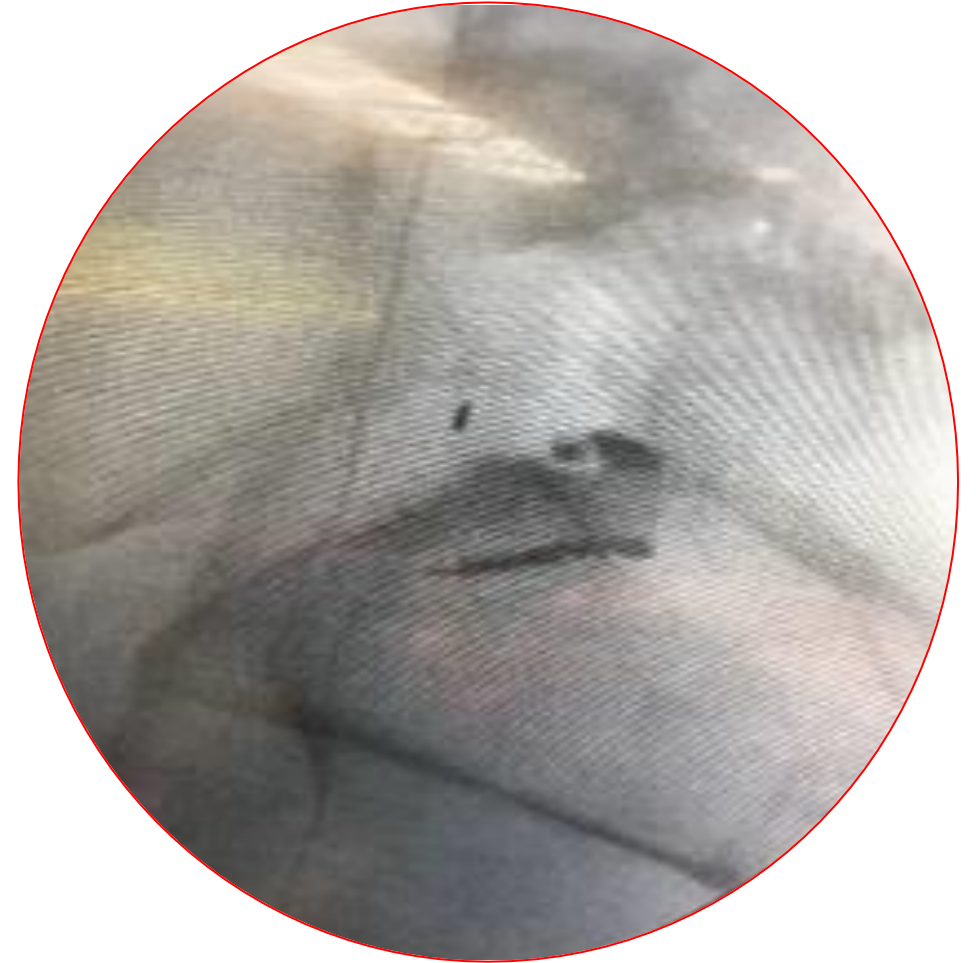
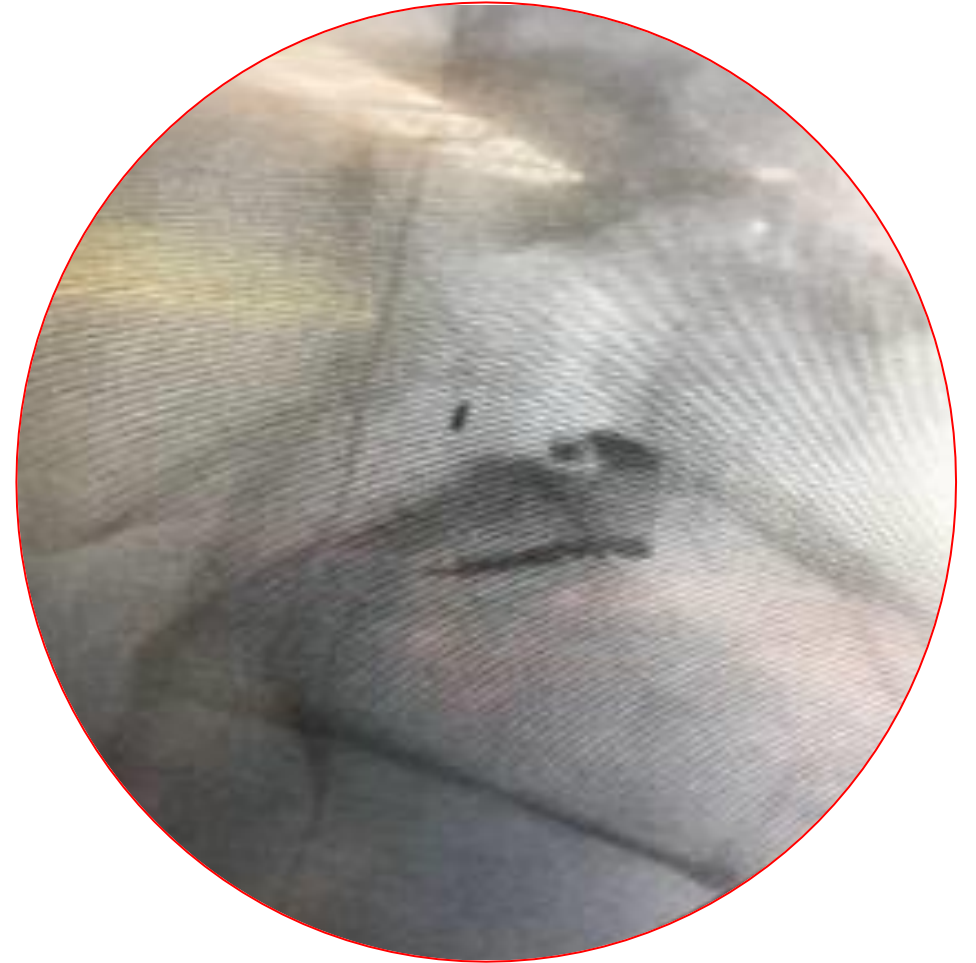
**Issue:** Anchor head striking the posterior wall (e.g., inferiorly at S1), doesn't cut through bone, and prevents appropriate implant depth/position

**Cause:** Delivery Tool changes angle during implantation, slides down posterior wall of vertebra

- Take fluoros throughout to catch instrument position changes (“tap, tap, fluoro”)
- Reverse Trendelenburg at L5S1 (to keep tool position orthogonal/vertical)
- Emphasize downward pressure to maintain delivery tool position

**Solution:** Remove the implant and consider placing in the opposing endplate
