Angled Toward the Endplate

Issue: Tool trajectory predicts the anchor will violate the endplate

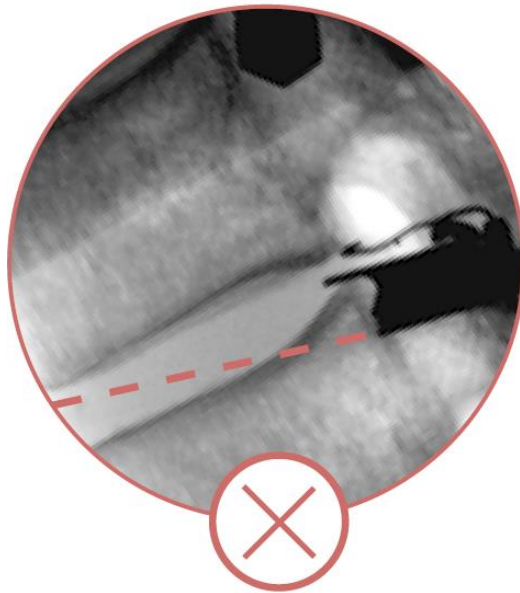
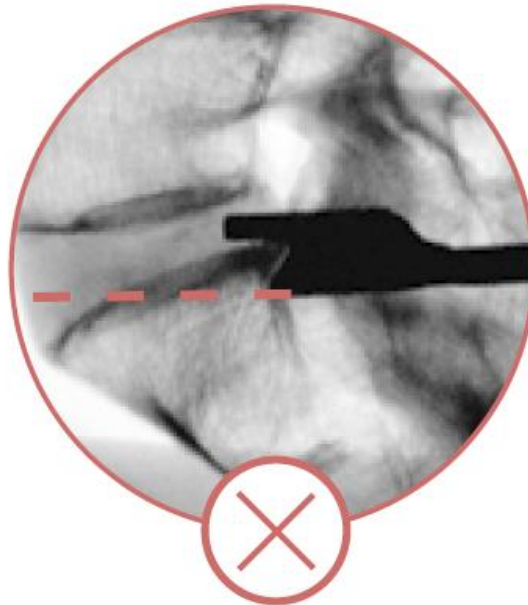
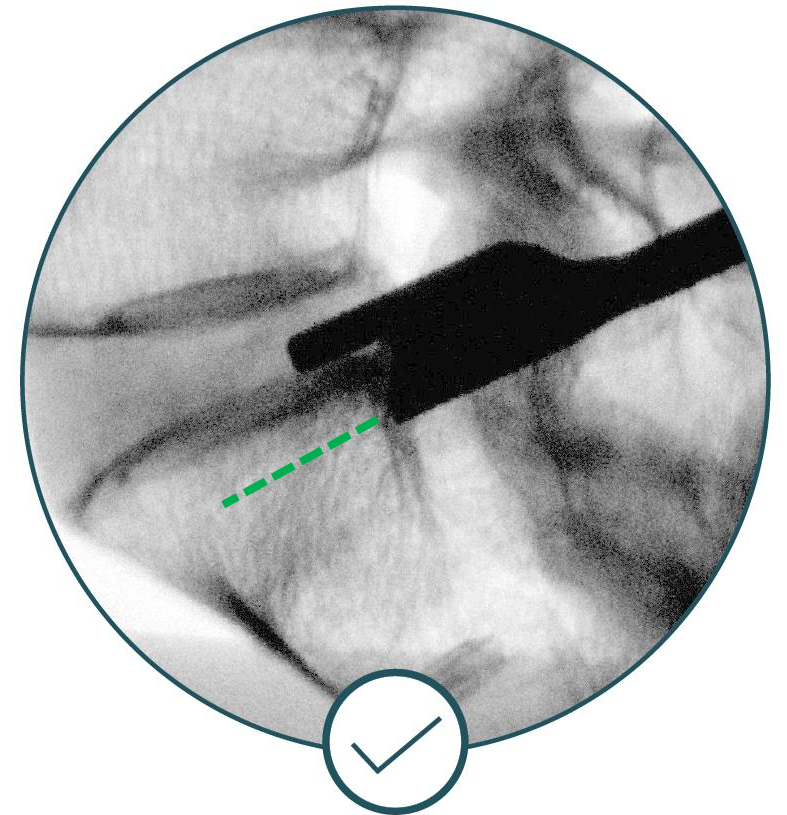
Cause: Distal end of tool is not against the posterior cortex of the target vertebral body

- Not enough lamina removed
- Tube position and/or skin incision location
- Fluoro hard to interpret
- Steep endplate cupping

Prevention: Do not implant without correcting!

- Solution:**
- Follow the cupping, even if means a steep implantation
 - Ensure fluoro image is in-plane and clear
 - Remove more lamina to get good trajectory
 - Wand the tube (loosen and re-angle)
 - Extend the skin incision if absolutely necessary and bony access is clear
 - Trial the opposing vertebra as possible alternative

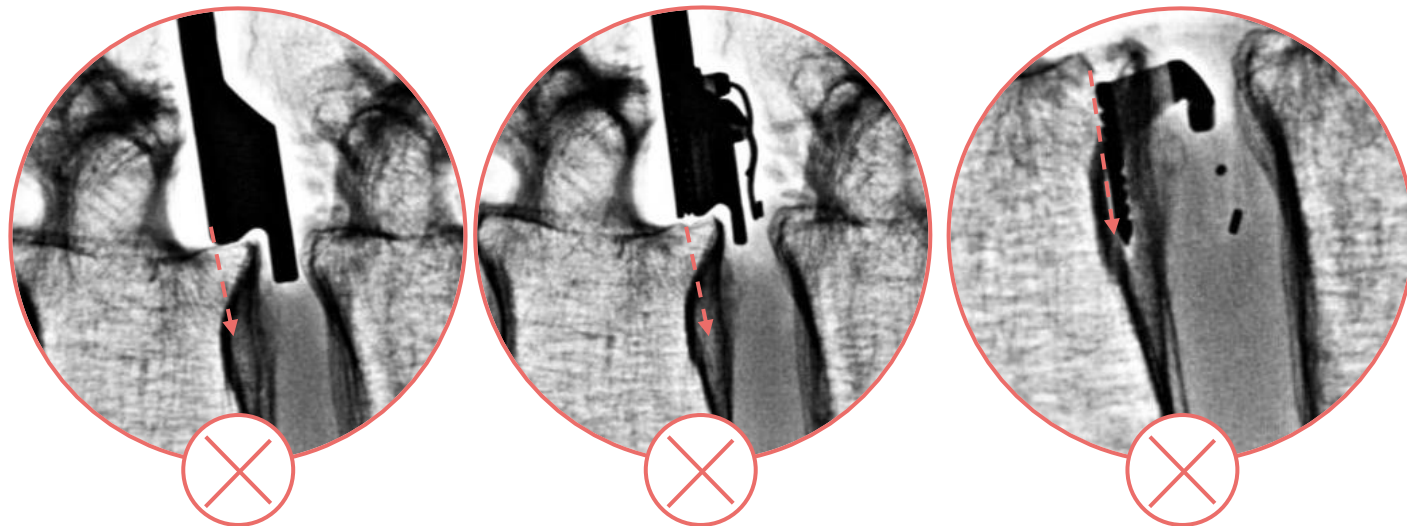
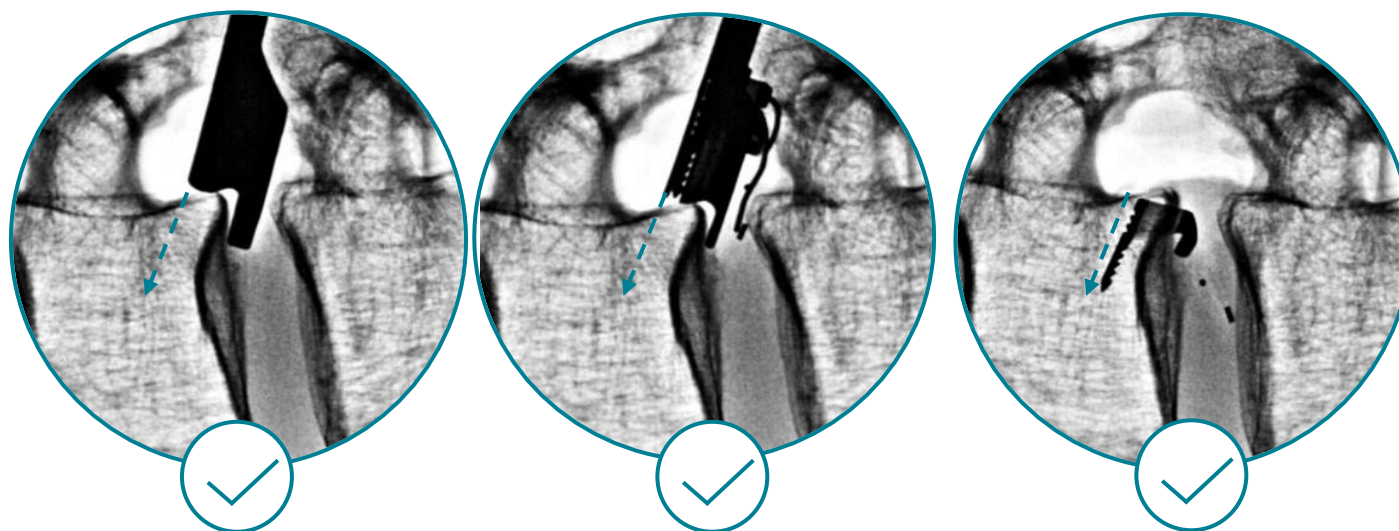
Angled Toward the Endplate

Do not implant without correcting!

Follow the cupping, even if means a steep implantation
