Accidental Deployment/Off-Loading

Issue: Anchor becomes detached from Pusher

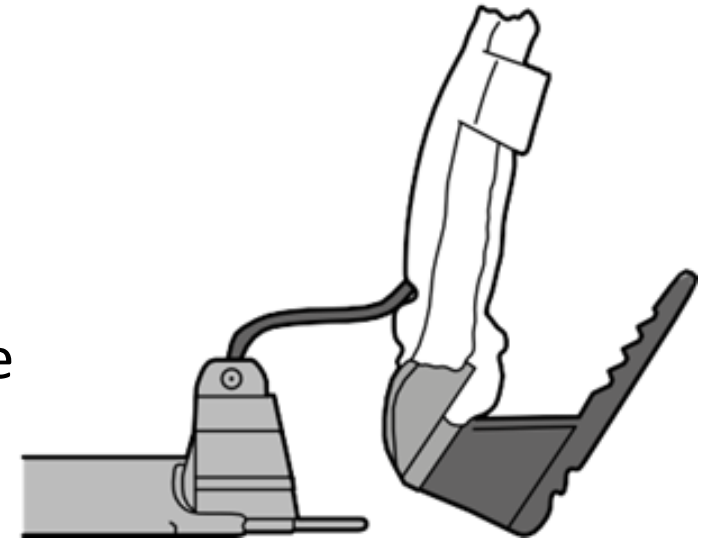
Do not touch the strike-cap

- Only hold the Delivery Tool by the **blue handle** – do not touch the white Strike Cap

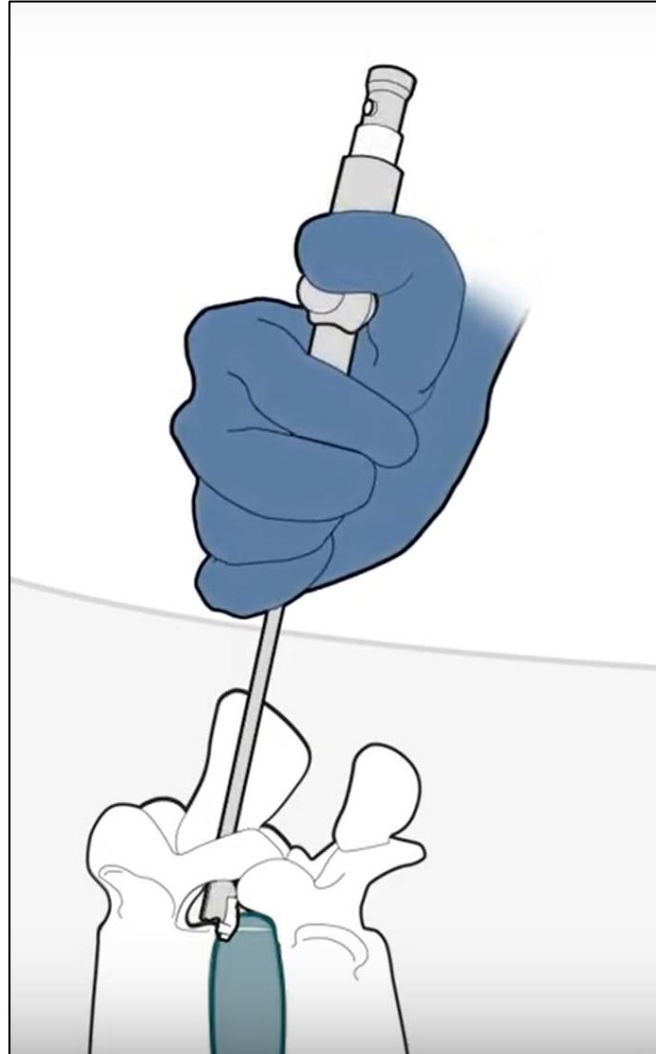
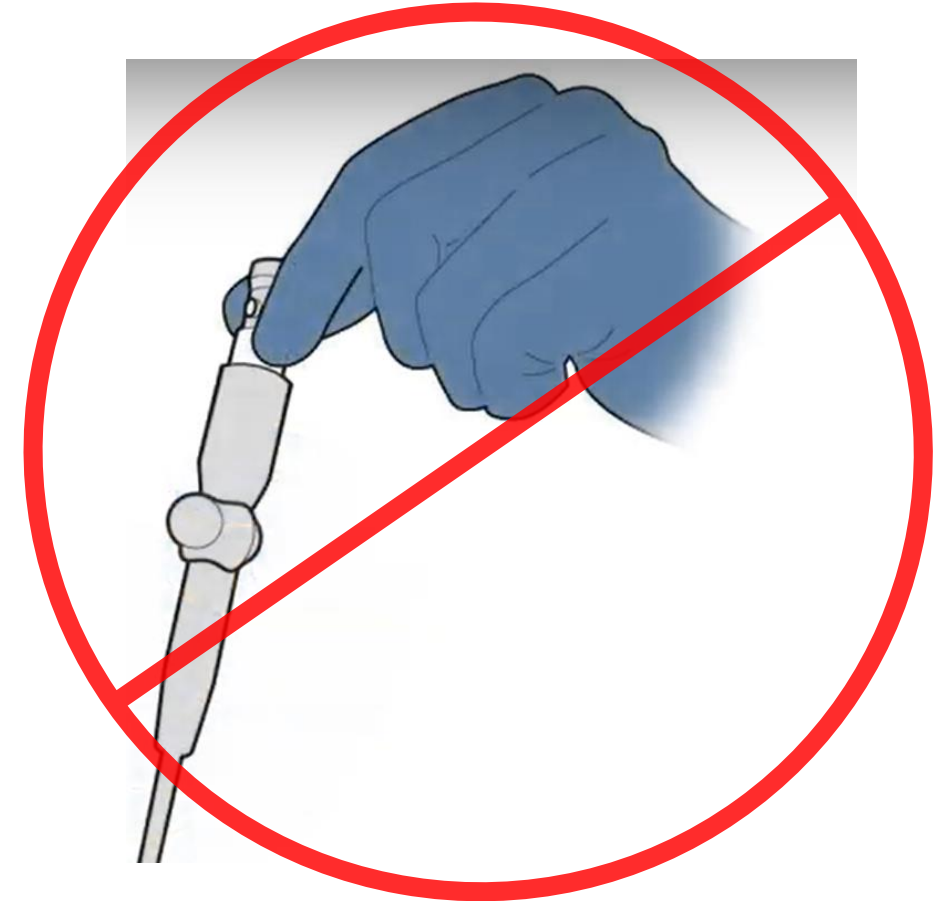
In with the blue, out with the white

- Only hold the Delivery Tool by the **blue handle** – do not touch the white Strike Cap
- The only time you should touch the Strike Cap is **if you have to remove the Delivery Tool to take out more bone...** then pull it out by the white (but don't touch the blue)

**"In with the blue,
out with the white"**

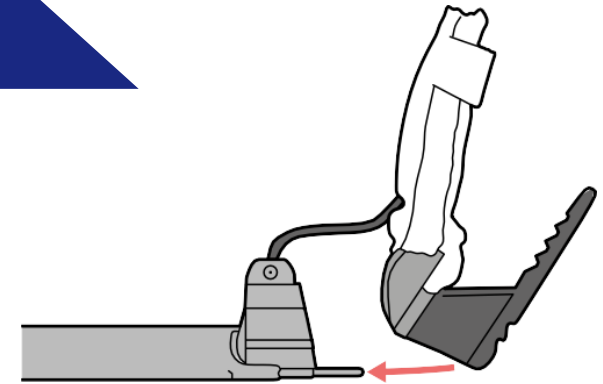
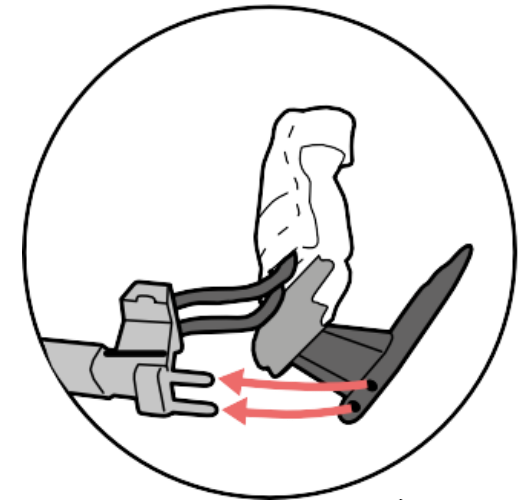
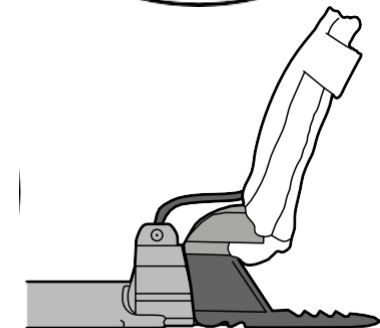
Solution:

- Always carry a loaded delivery tool into surgery to demonstrate reloading
- Explain how to reload the implant, and/or show this video, and see if they can reload the device
- If they can't reload, open a new implant
- Comp the wasted one or charge for it if you feel it was avoidable
