# Can't Remove Pusher Rod

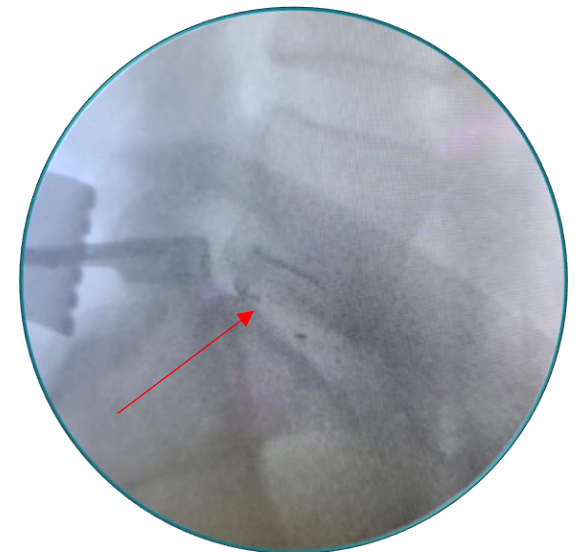
**Issue:** Difficult to remove the Pusher (particularly the guide-wire) from the disc after implantation

**Cause:** The distal end of the wire is very stiff and needs to bend pretty flat to be removed – this can be challenging particularly in short discs

**Prevention:** Use the bottle-cap technique with the black Retraction Wedge while the Delivery Tool is still assembled

**Solution:**

- Two-hand technique: One proximal, one distal
- Put strike-cap back on (more leverage)
- Use Mallet as a slap-hammer (with the strike-cap on)
