Removal Tool Tynes Splayed

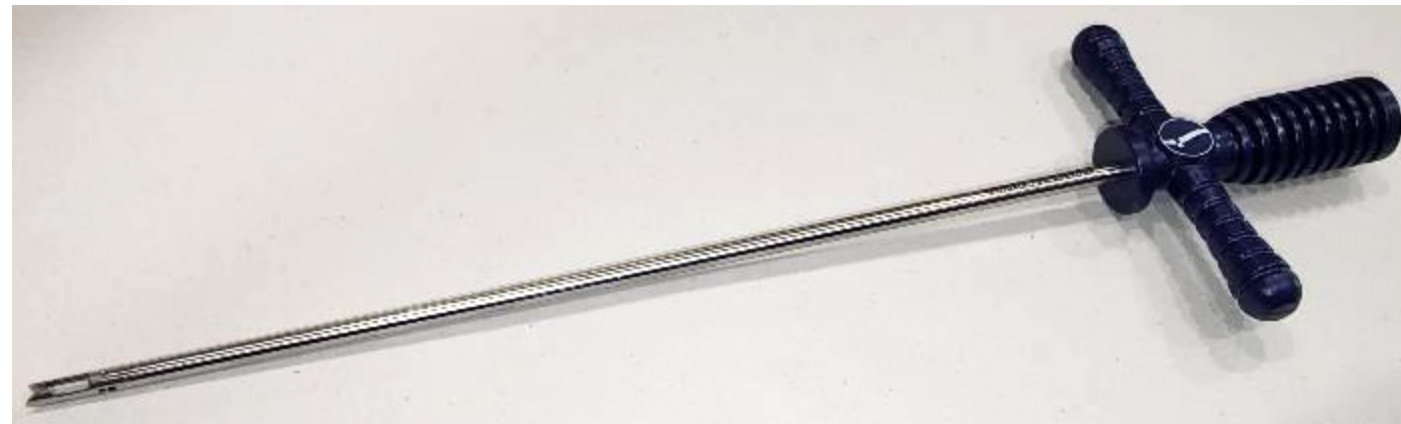
Issue: The distal extensions on the Removal Tool are bent outward during use

Cause: Either over-rotation, or incomplete insertion.

Prevention:

- Confirm the Removal Tool is against the back of the anchor before rotating
- Ensure tool is only rotated 45° clockwise (and no further!) to capture the anchor

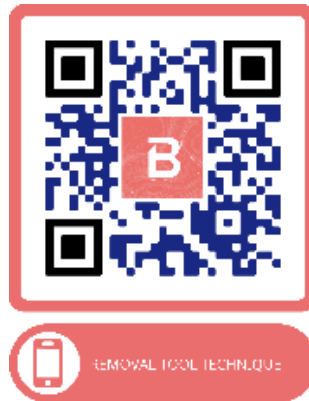
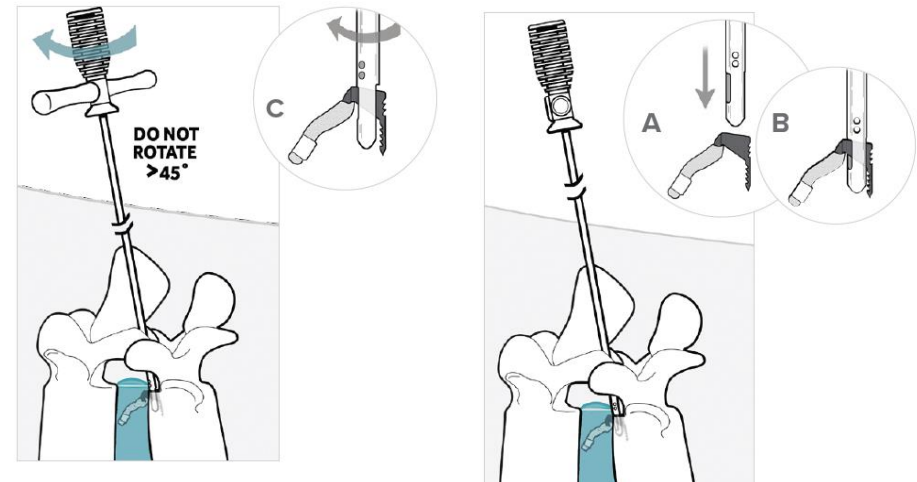
Removal Tool Tynes Splayed

Solution:

- Use a new removal tool – confirm the removal tool is all the way down (back of slot is against the back of the anchor) before rotating
- Re-emphasize that the removal tool is only rotated 45° clockwise (and no further!) to capture the anchor
- Report to Quality at www.barricaid.com/complaints/, and return the damaged Removal Tool to Intrinsic in the return box
